VERIFICATION OF THE MATERIAL PROPERTIES OF THE STRUCTURE ELEMENTS OF COMPRESSOR STATION FOR THE NEEDS OF THEIR REDESIGN

Received – Prispjelo: 2014-04-28
Accepted – Prihvaćeno: 2014-09-25
Preliminary Note – Prethodno priopćenje

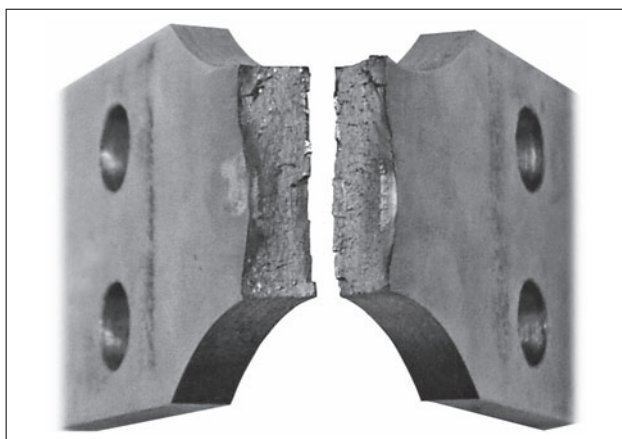
Figure 6 2 parts of specimen after the low-cycle fatigue test

For the fatigue properties tests specimens were removed from the detached ring from location 11 and specimens containing weld from locations 12, 13 for test by flat bending and from locations 14 and 15 for tensile tests (Figure 4). Shape and size of the test specimens were selected so that the transition area of the weld was located in the thinnest part of the specimen. Tests were performed on a testing pulsator, which allowed dynamic tests during alternating symmetrical bending at loading up to 400 Nm. In first stage of the tests stress amplitudes $\sigma_a = 240$ MPa were selected. In this mode, specimens remained undisturbed even at $2,6 \times 10^6$ cycles. In second stage, the amplitude was increased to level $\sigma_a = 450$ MPa, which for given material already represents an area of low-cycle fatigue. Specimens failure occurred at level 8×10^3 cycles, with the shape of fatigue fracture according to Figure 6. Fatigue crack initiated at the edge of the test specimen according to Figure 7, in location of welding joint imperfection. Nature of the fracture line is illustrated on Figure 8

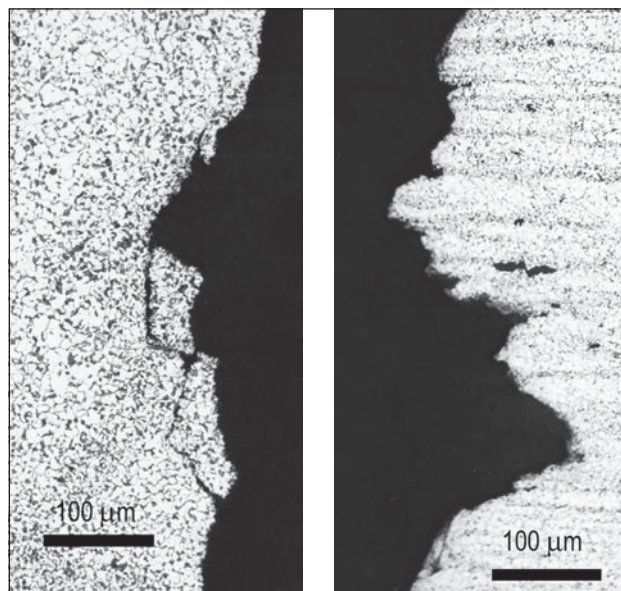
Figure 8 Profile of the fracture line on the failed test specimen and on the specimen with secondary cracks

on the left. Fatigue crack spreading was also influenced by inclusions in base material and by rows of perlite. Secondary cracks parallel to rows of perlite are visible in Figure 8 on the right.

The results of metallographic analysis show that under given conditions of stress initiation of fracture process occurred in the area of weld metal and the spread of the fracture itself took place in base material.

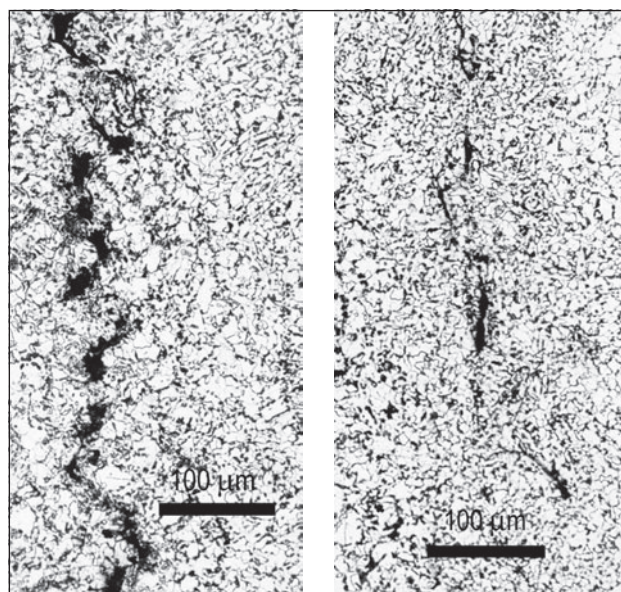
Figure 9 Microcracks in the area of welding joint and in the transition area

Figure 9 shows microstructure of the transition area. Microcracks were identified in the area of the welding joint, specifically on the intersection of weld metal (Figure 9 left) and heat affected area (Figure 9 right).

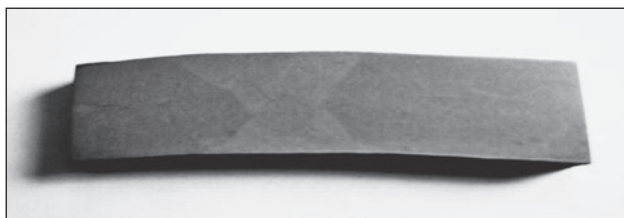
Figure 10 Cross-cut section of pipe wall with welding

Weld metal is entire, shaped as "X" and comprised of multiple layers (Figure 10).

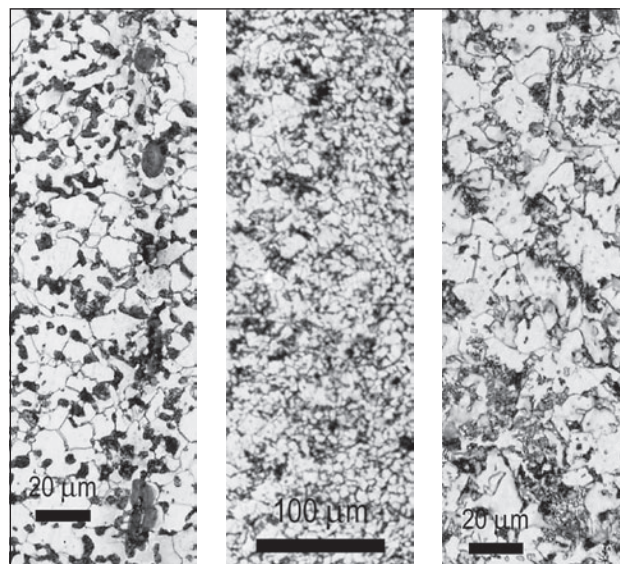
Figure 11 Microstructures: base material, heat affected area and weld metal

Microstructure of the base material (Figure 11 left) is ferrite-perlite of ferrite grain less than $0,015 \mu\text{m}$. Characteristics of structure correspond to a state after

annealing. Figure 11 in the middle illustrates transition from the heat affected area to the area of weld metal. Transition is smooth; ferrite-perlite structure is coarser with oriented arrangement. Figure 11 on the right shows microstructure in the area of weld metal. Structure consists of ferrite and perlite with directed arrangement of perlite. Structure also contains small cement particles.
